## Facility Condition Assessment Report

Assessment Date: 2026-08-11

Site description: Storm Damage

Task description: Assess the damage, path and debris field, estimate total amount of damage, equipment and type of loss

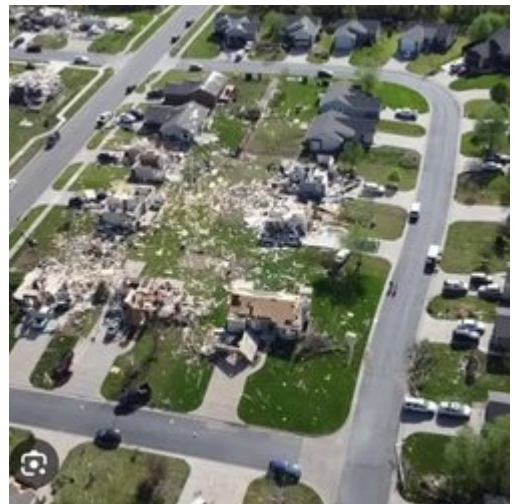
### Issue # 1

**Description:** Ten residential buildings are in a state of partial or complete destruction. Several structures are reduced to debris with exposed foundations.

**Severity:** Critical

**Recommended Action:** Immediate on-ground structural assessment by a qualified engineer is required for any remaining structures. Demolition and site clearing required for completely destroyed buildings.

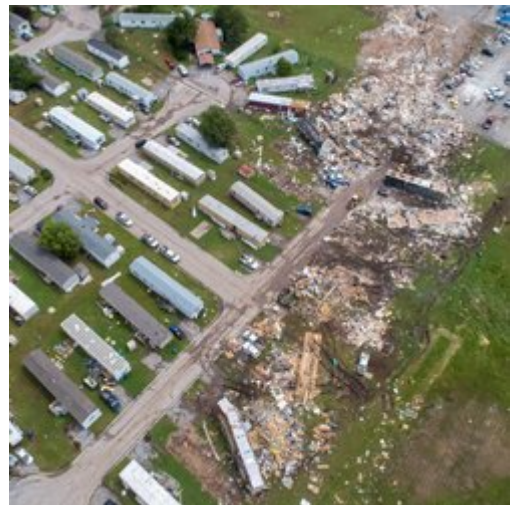
## Issue # 2

**Description:** Seven mobile homes have been completely destroyed and reduced to a large debris field, indicating catastrophic structural failure.

**Severity:** Critical

**Recommended Action:** Site requires complete debris removal and clearing. Assess foundations for potential reuse or removal.

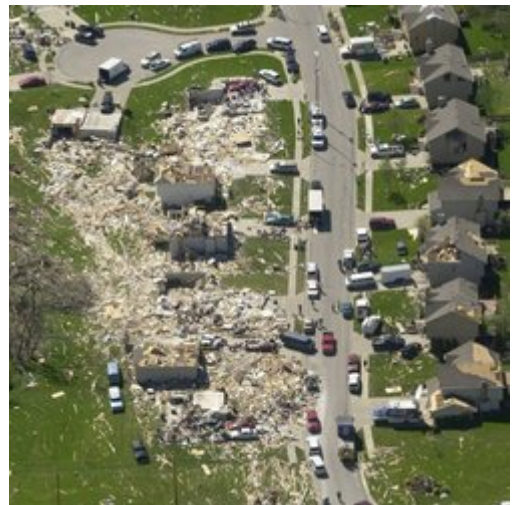
### Issue # 3

**Description:** Eight residential buildings are completely destroyed and reduced to their foundations with extensive debris fields.

**Severity:** Critical

**Recommended Action:** Immediate on-ground structural assessment of foundations is required. Demolition and site clearing required for all affected lots.

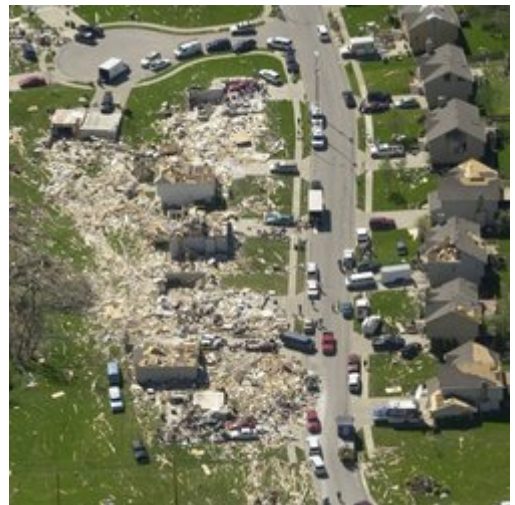
## Issue # 4

**Description:** Twelve residential buildings that remain standing have sustained severe roof damage, with large sections of roofing, sheathing, and framing missing.

**Severity:** High

**Recommended Action:** A qualified roofing contractor and structural engineer should assess the extent of the damage to determine if repair or full replacement is necessary. Temporary tarping should be installed to prevent further water intrusion.

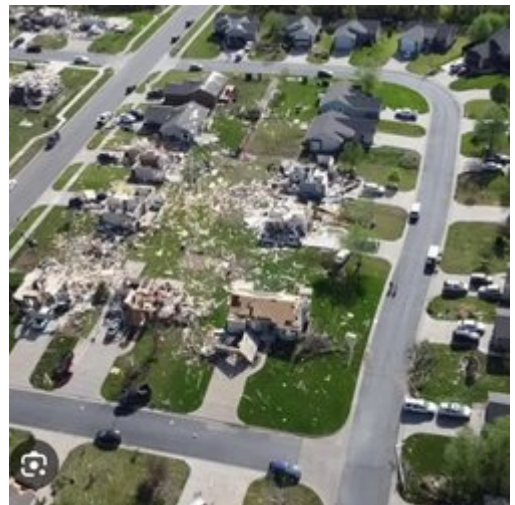
## Issue # 5

**Description:** Widespread debris from destroyed structures is scattered across lots, roads, and adjacent properties, posing a significant safety and access hazard.

**Severity:** High

**Recommended Action:** Engage a professional debris removal service to clear all affected areas. Test for and abate any hazardous materials found within the debris.
